Commercialization of Military & Space Electronics - Conference

Commercial Off-The-Shelf (COTS) Program

Using Nondestructive Methods (C-SAM) for COTS
PEMs Screening and Qualification

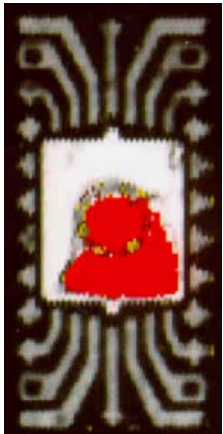
Reject

C-SAM Rejects (JPL examples): (Devices with $\gg 10\%$ delamination in critical areas are suspect and are rejected)

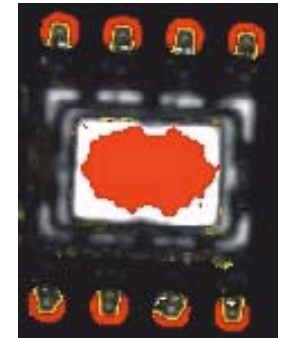
Pass*

*Delamination is not evident because of die top coating used by the manufacturer. (e.g. C-SAM limitation)
